lred MCX 1034USB

For Servo Debug 2006 02 09

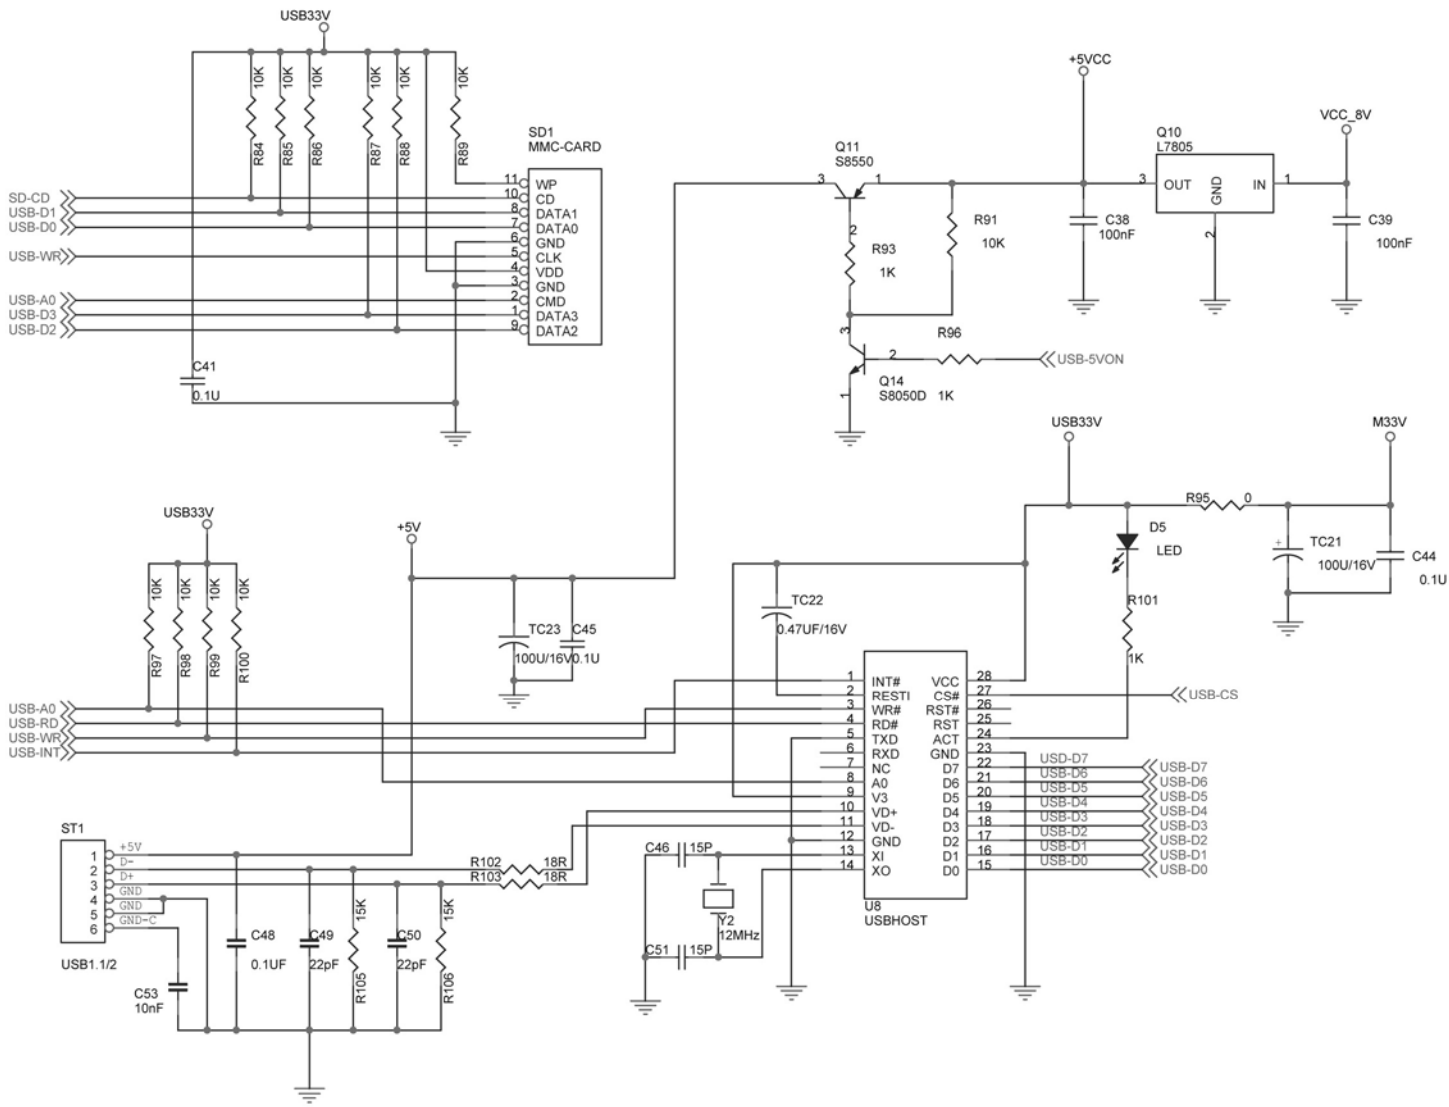
U1 Pin93 -Pin100 and Pin111 -Pin113 and Pin116 is GPIO

- TP1 FELPFD
- TP2 TELPFD
- TP3 SBLPFD

MOTOR Input Choose

| Sanyo | R14 R25 R35 OR | R39 5.1K |
| Sony | R14 R25 R35 OR | R39 3.3K |
| Samsung | R14 R25 R35 OR | R39 8.2K |

Change Value from 10K to 1K
Change by 2006 02 09

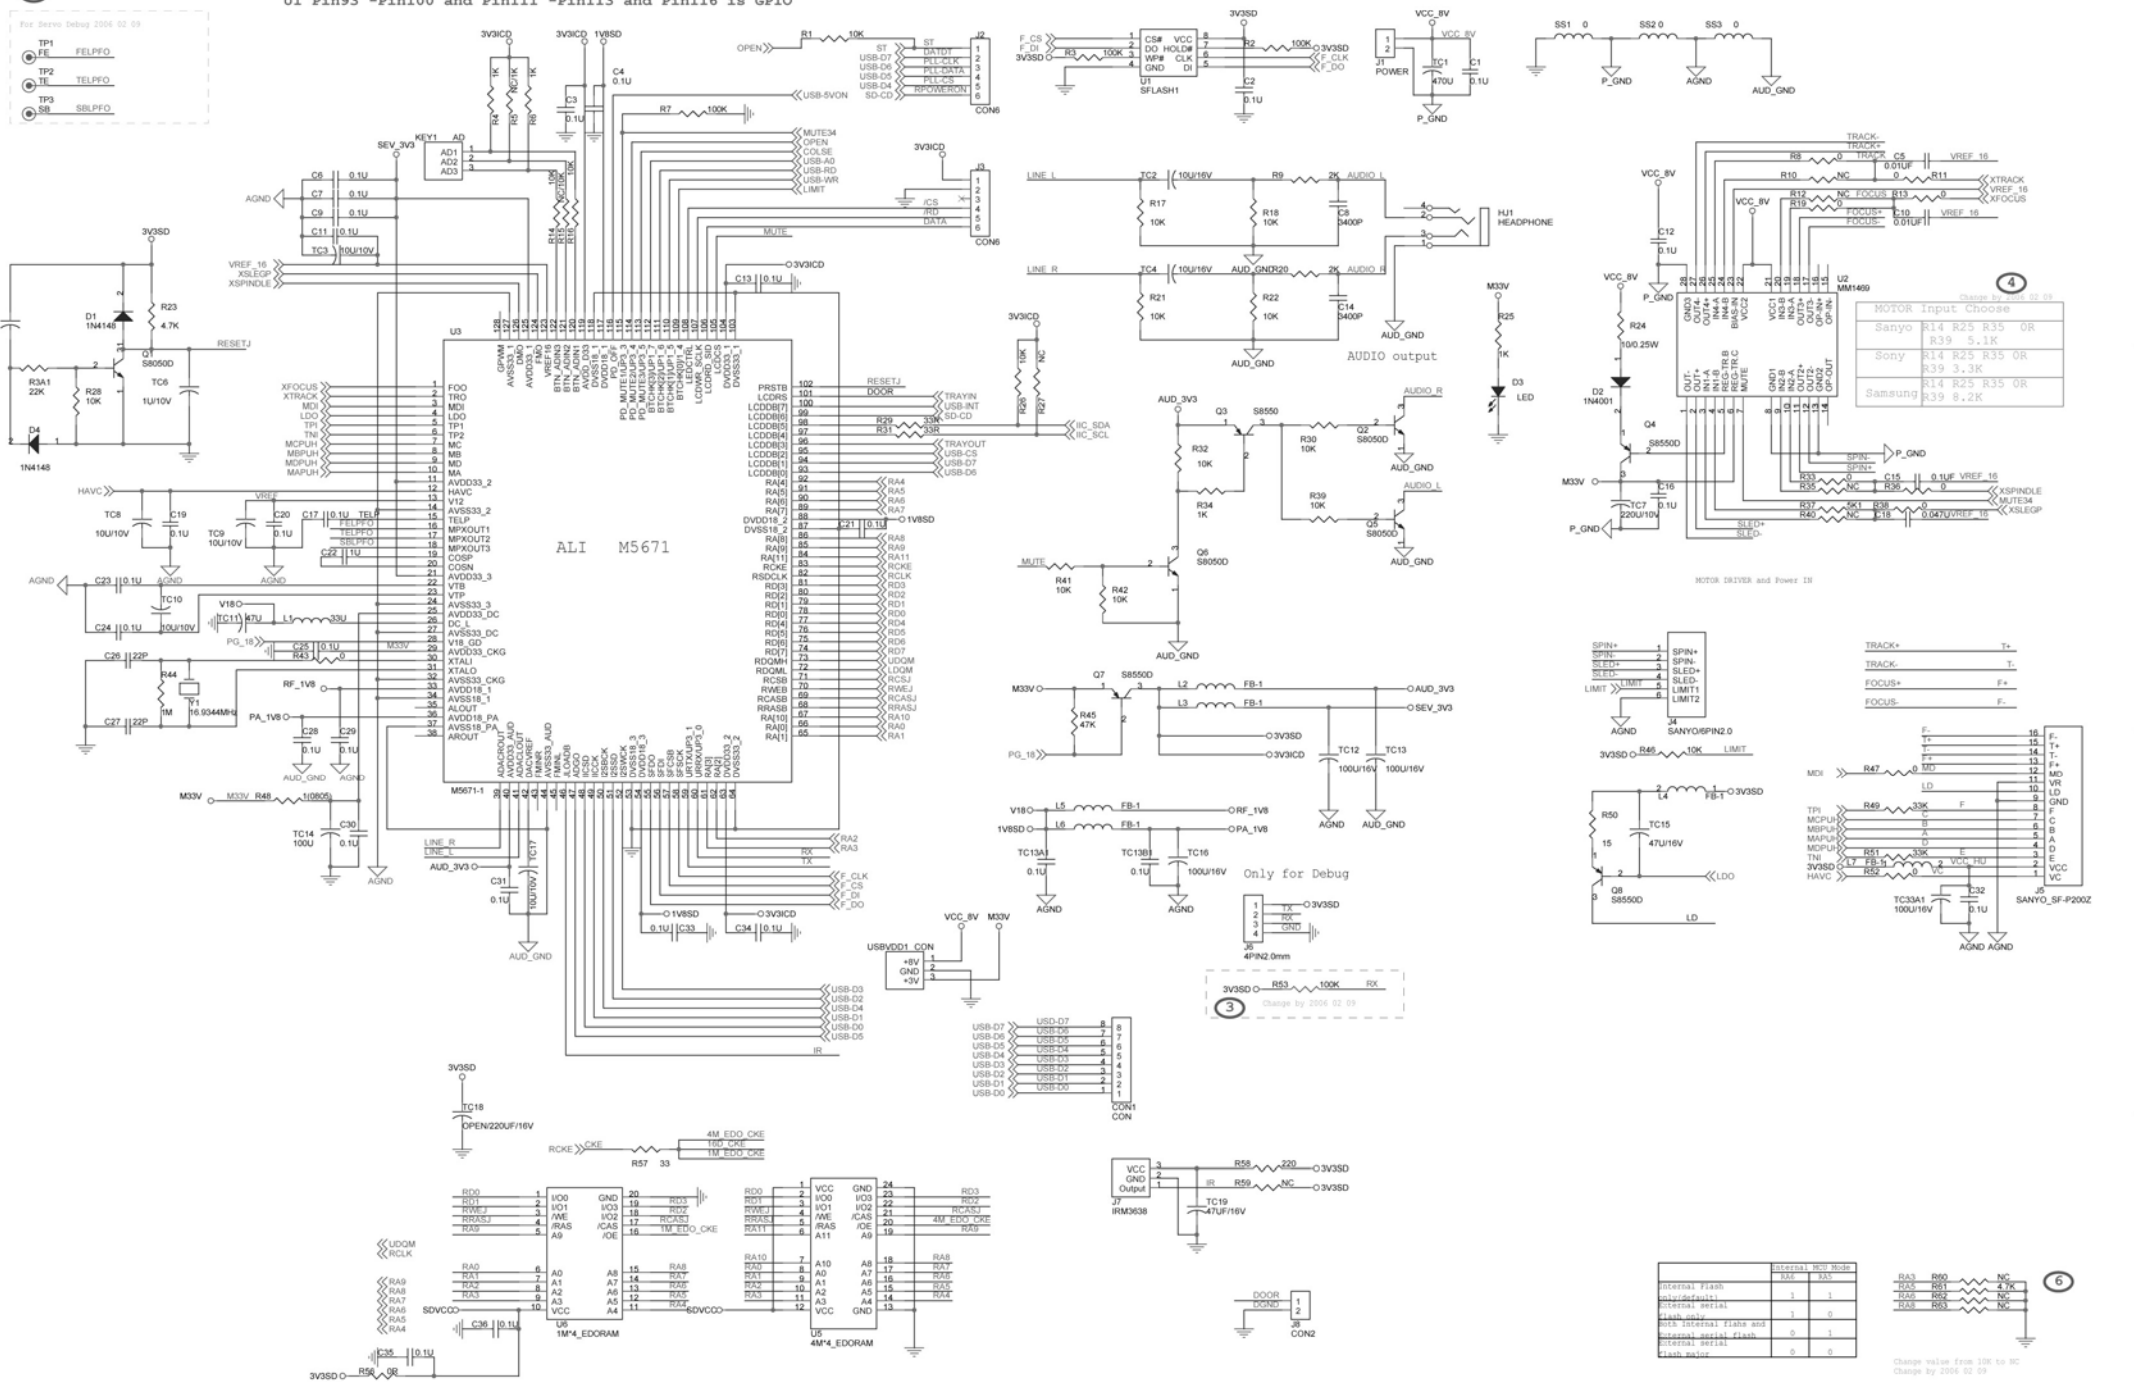
Change By 2006 02 09
